WATER WORKS LAKE DAM  
RANDOLPH COUNTY MISSOURI  
MO. 10006

**PHASE I INSPECTION REPORT**  
**NATIONAL DAM SAFETY PROGRAM**

NOVEMBER 1979

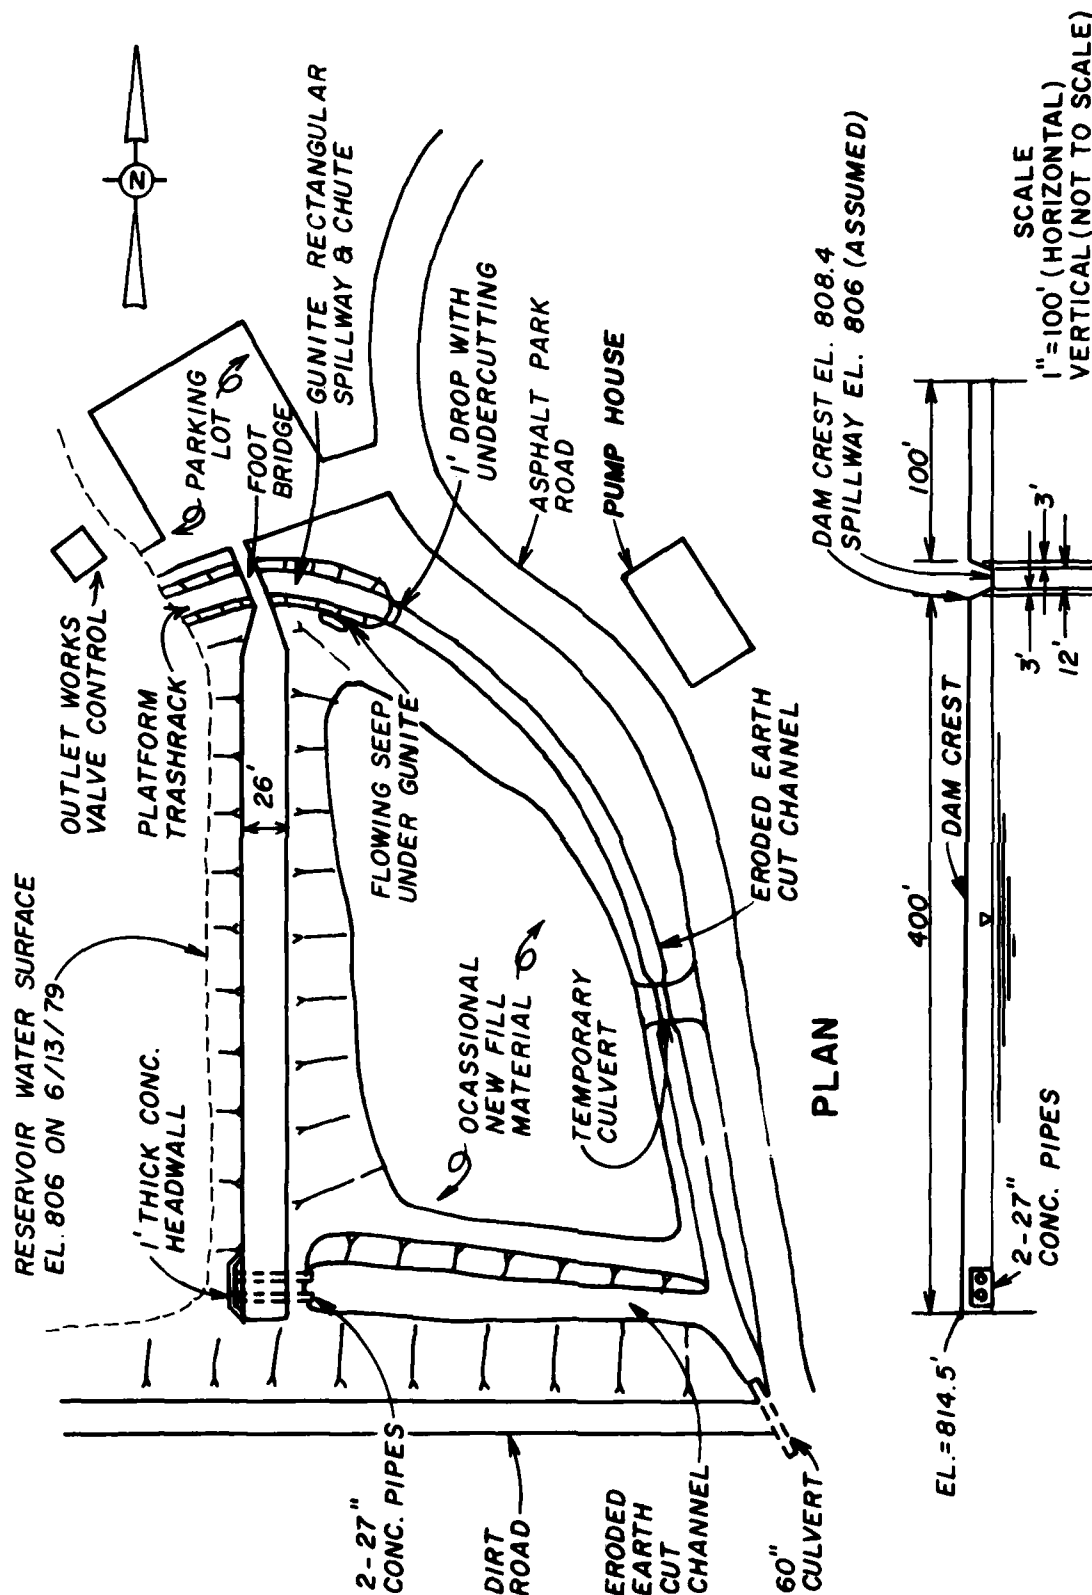
PLATE 2

WATER WORKS LAKE DAM (MO. 10006)  
PLAN & ELEVATION

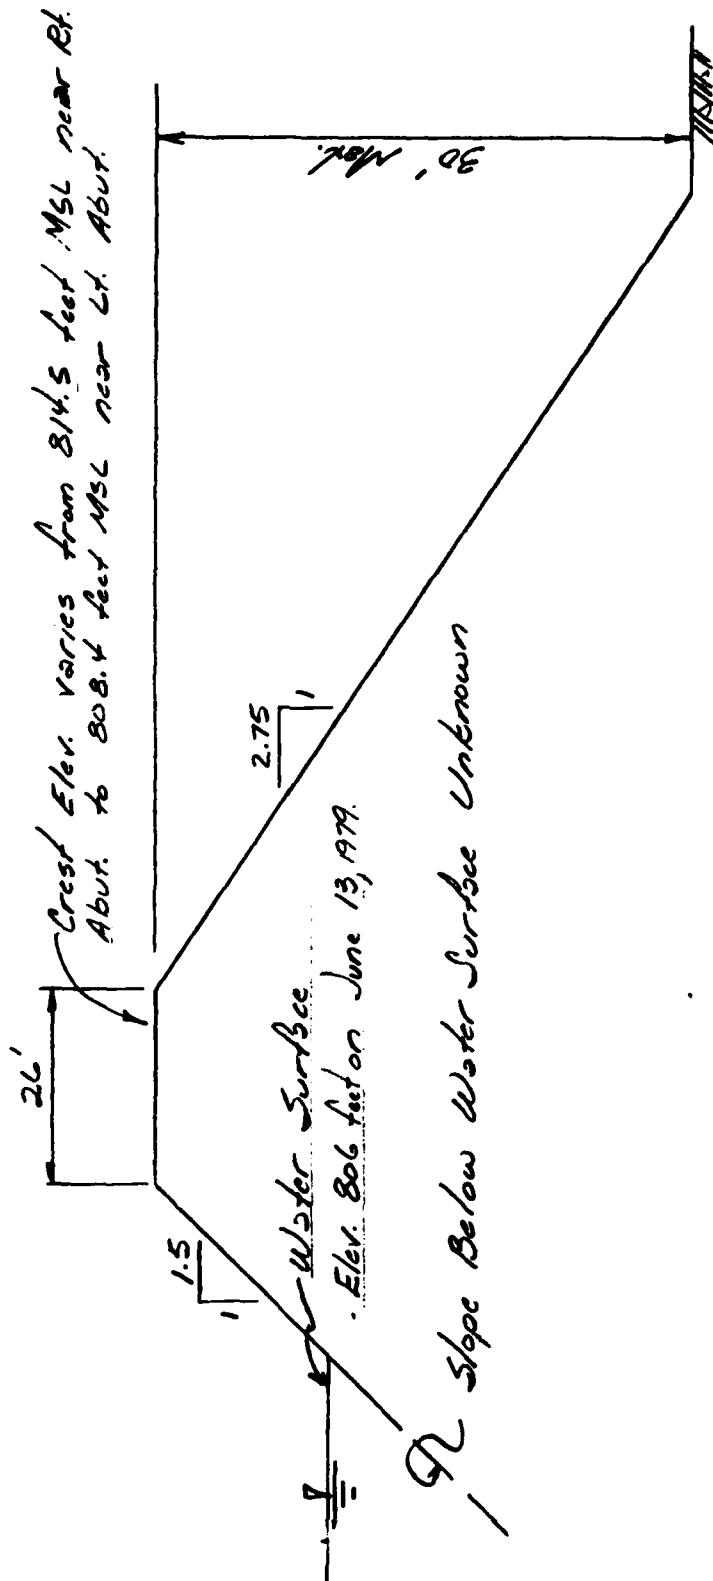
Water Works Lake Dam (Mo 10006)  
TYPICAL SECTION OF EMBANKMENT

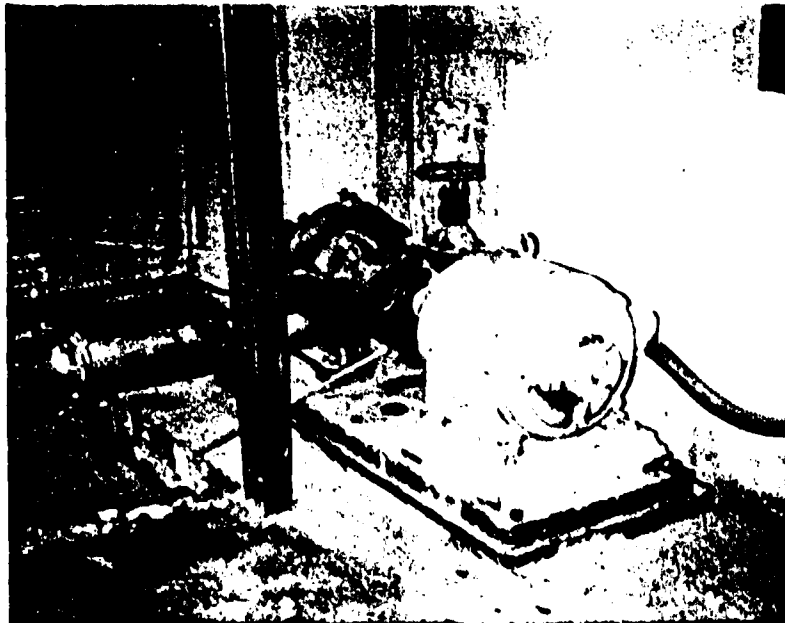
Photo 14

| Photo 14. | - | View of the electric driven pump. |
